Inventory Company.

Property inspected by Amir

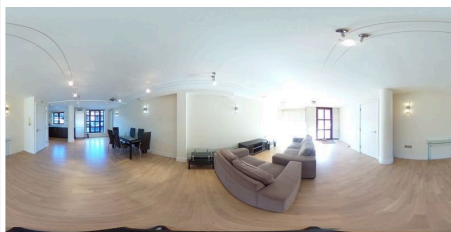
5.2	Front Door	UPVC double glazed. Obscured glass. Chrome handle. Doorbell (wireless). Chrome Letterbox. Exterior light	Exterior light bulb working. Tarnished handle (front). Tarnished handle (reverse). Scratched (front side). Scratched (reverse side). Dusty (reverse side). Dusty (front side). Dirty (reverse side). Letter box flap missing. Marked and scratched throughout	As Inventory

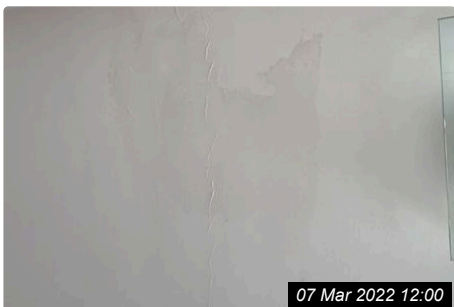
Ref # 5.6 - Discolouration and damp forming on the RHW

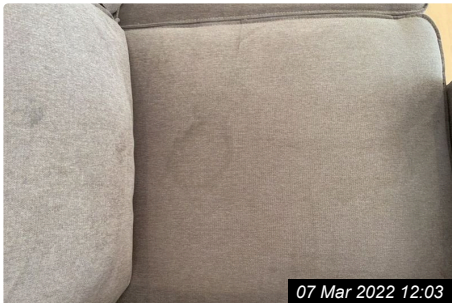
Ref # 5.12 - 3 seater Marks and smudges arm LHS and seating

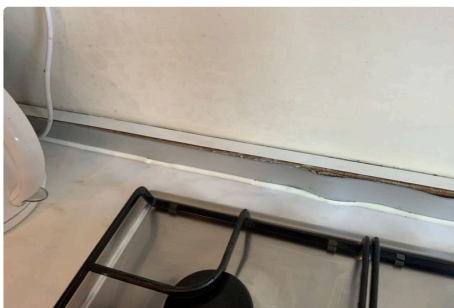
Ref # 6.4 - Stains to wall behind hob

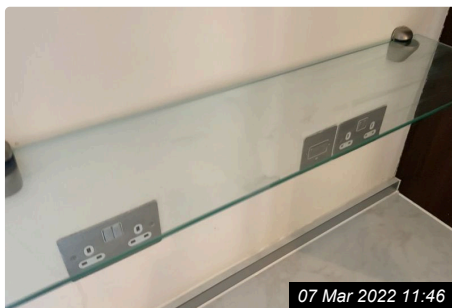
Ref # 6.4 - Smudges top side

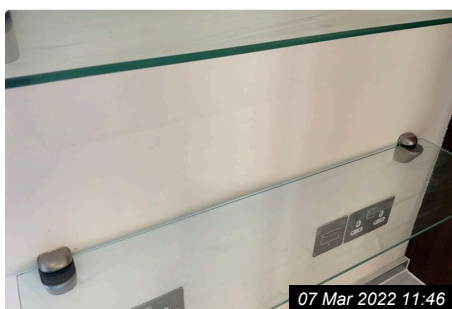
Ref # 6.4 - Smudges top side

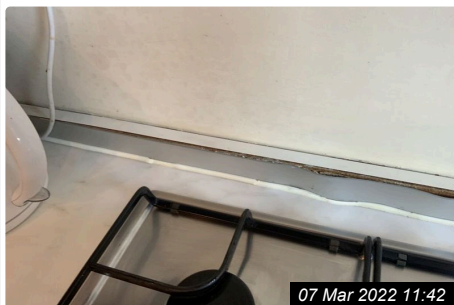
6.8	Kitchen Cupboards/Units	<p>Wall units present. Base units present. Brushed chrome handles. 5 x laminated wood. 6 x silver matt effect</p>	<p>All handles and hinges intact. Free of items inside. Free of stains underneath sink. Free of grease and food residue inside. Sticky handles. Some unit doors smudged and stained and scratched</p>	<p>Damage to the Sill Behind the sink and hob.</p> <p>Needs Repair - Tenant</p>
-----	-------------------------	---	---	---

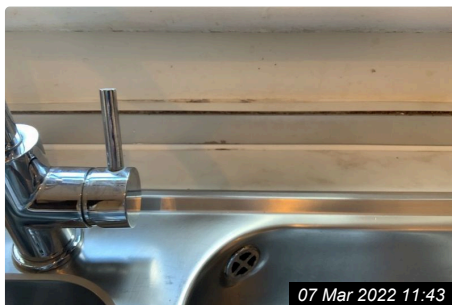
Ref # 6.8 - Sill Behind the sink and cooker damaged

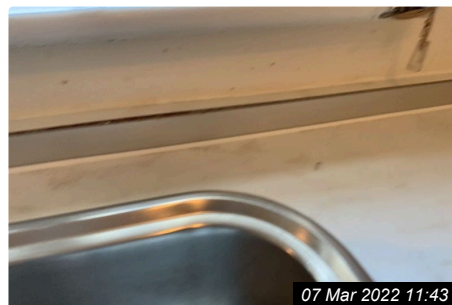
Ref # 6.8 - Sill Behind the sink and cooker damaged

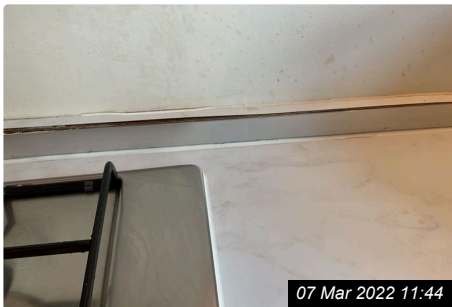
Ref # 6.8 - Sill Behind the sink and cooker damaged

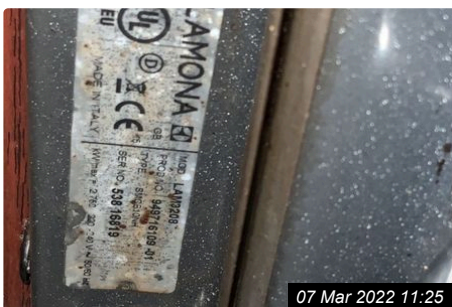
6.12	Hob	Gas hob. 4 rings	Rings intact. Dial markings worn. Free of grease and food residue. Free of dust. Dials/knobs intact	As Inventory	
6.13	Oven	Oven and grill. Chrome rack x 2. Baking tray x 1. Greasy residue inside. S/n: 53816819	Dried food residue inside. Burnt carbon residue inside. Free of grease and food residue inside. Seal intact and door hinge functioning smoothly	As Inventory

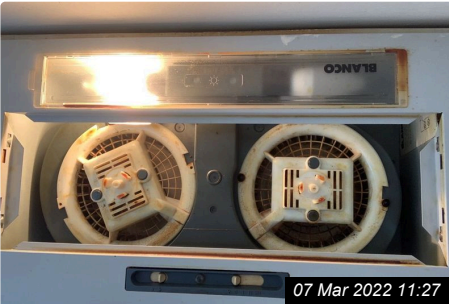
Ref # 6.14 - Both fan/motors and frame internally greasy/Oily

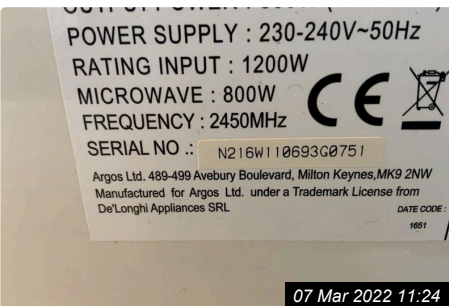
6.15	Microwave	Microwave only. Delonghi <i>Serial nr;</i> N216W110693G0751;	Free of food residue. Free of grease and food residue inside. Buttons/ dials clean and intact to front. Bulb working inside. Mark seen to lhs inside of microwave	As Inventory
------	-----------	--	---	--------------

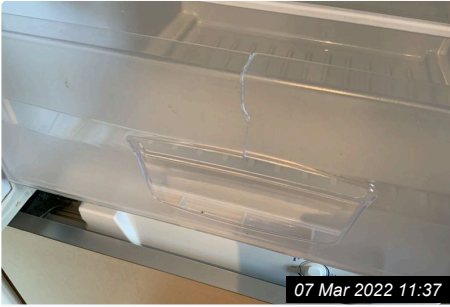
Ref # 6.16 - Salad drawer cracked

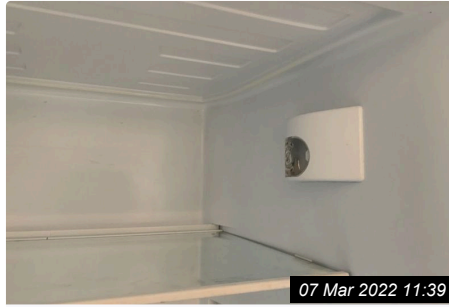
Ref # 6.16 - Lightbulb doesn't seem to be working

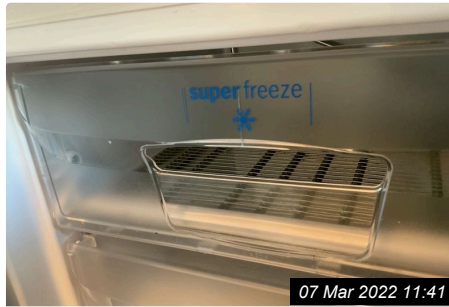
Ref # 6.16 - Front cracked

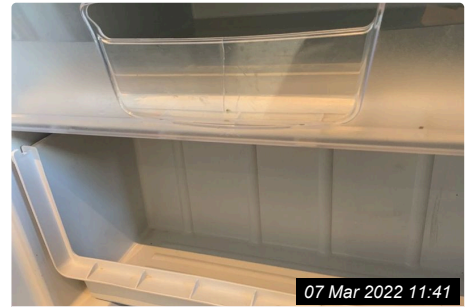
Ref # 6.16 - Front cracked

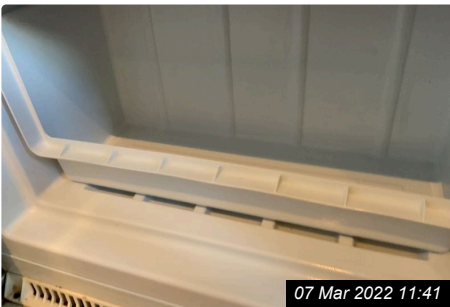
Ref # 6.16 - Missing front freezer drawer

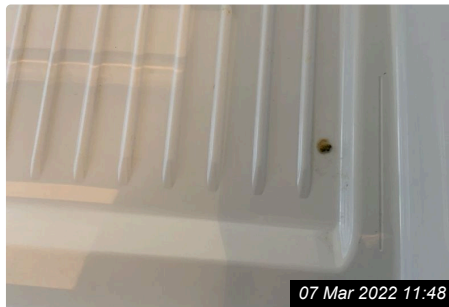
Ref # 6.16 - Salad drawer cracked and mark inside and rhs

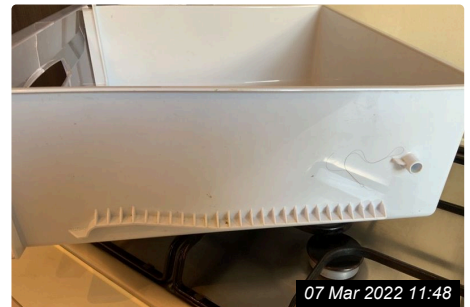
Ref # 6.16 - Salad drawer cracked and mark inside and rhs

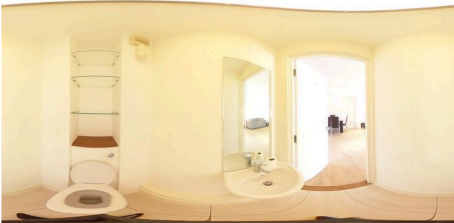
<p>07 Mar 2022 12:52</p> <p>Ref # 7.1</p>

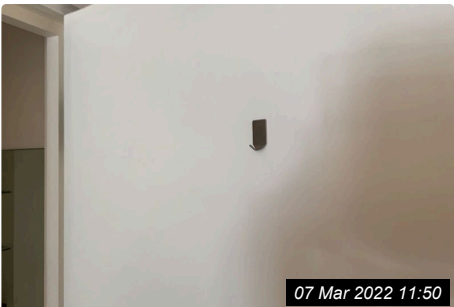
<p>07 Mar 2022 11:50</p> <p>Ref # 7.2 - Reverse silver hook</p>

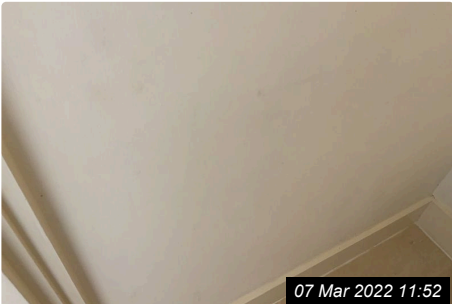
<p>07 Mar 2022 11:52</p> <p>Ref # 7.7 - Smudges LHW and back wall lower level</p> </div> <div>

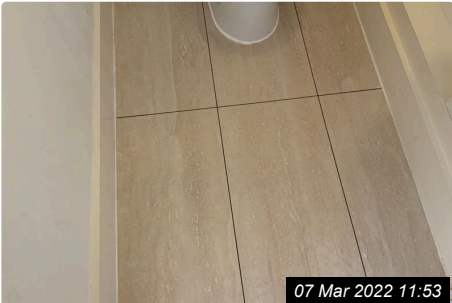
<p>07 Mar 2022 11:53</p> <p>Ref # 7.8</p> </div>					
7.9	Sink/Basin	Wall-mounted porcelain. Mixer tap. Chrome taps. Chrome waste	Basin intact and free of cracks/chips. No gaps to sealant around edges. Clean and free of hairs. No limescale present to taps. Waste is tarnished	As Inventory

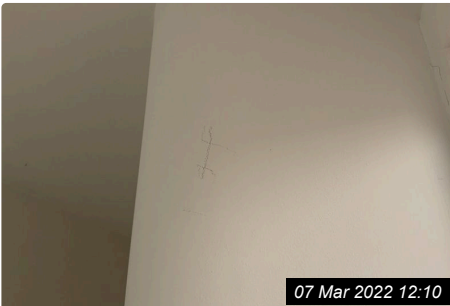
Ref # 8.6 - RHS above the switch

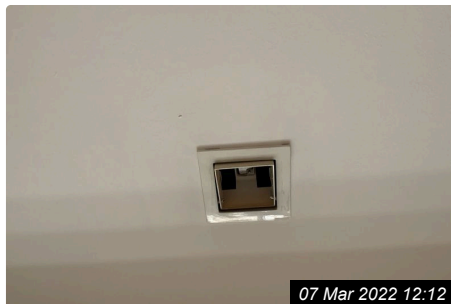
Ref # 8.9 - Spotlight near bedroom not working

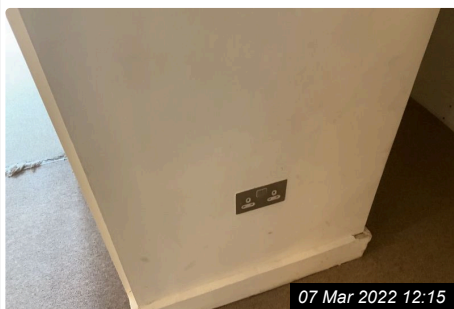
Ref # 8.13 - Marks and smudges corner damaged

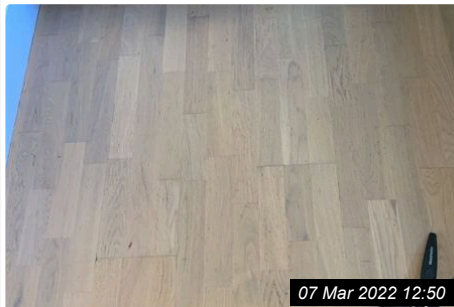
Ref	Name	Description	Condition at Inventory	Condition at Check Out	Additional Comments
9.1	General Overview		Clean and tidy. Neutral smell (no smoking or pet odours).	<i>As Inventory</i>

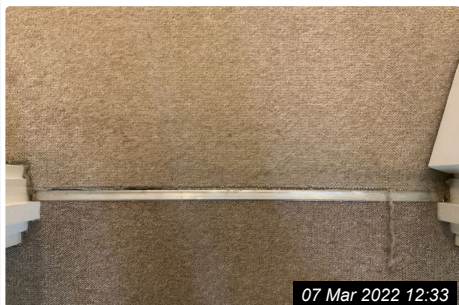
Ref # 10.10 - Worn near threshold

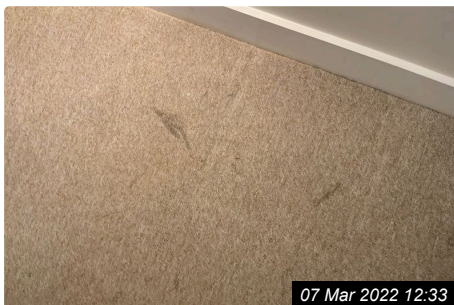
Ref # 10.10 - Various marks and smudges near door and back door

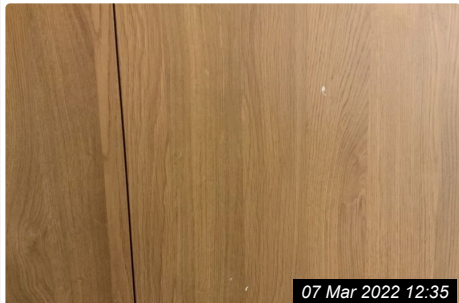
Ref # 10.11 - Paint marks rhs door

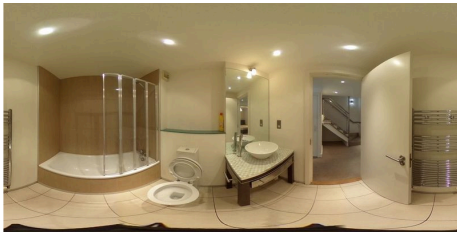
12. BATHROOM (CONT.)

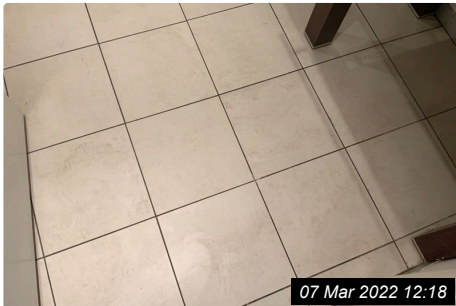
Ref # 12.10 - Various dark marks throughout

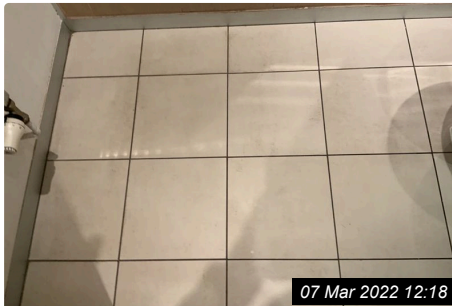
Ref # 12.10 - Various dark marks throughout

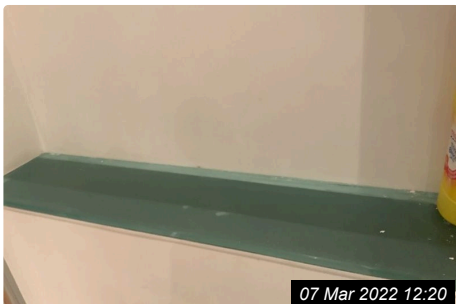
Ref # 12.15 - Sill at the back paint and marked

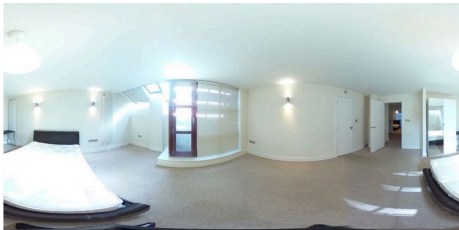
<p>07 Mar 2022 12:41</p> <p>Ref # 13.1</p>

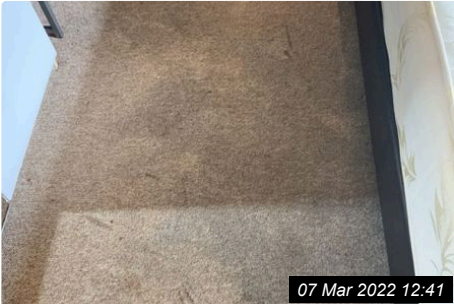
Ref # 13.10 - Dark mark LHS of bed

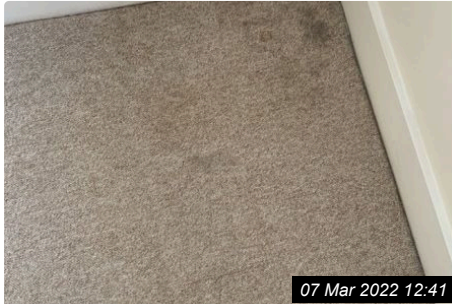
Ref # 13.10 - Marks and worn in places

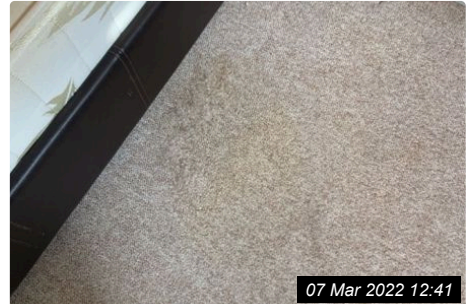
Ref # 13.10 - Marks and worn in places

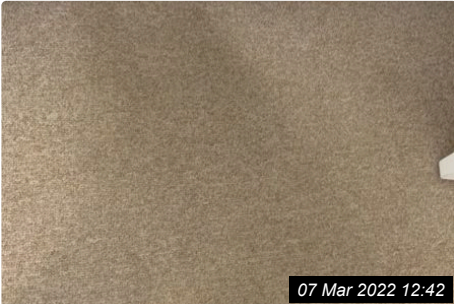
Ref # 13.10 - Marks and worn in places

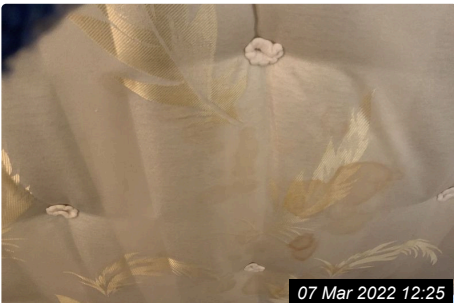
Ref # 13.11 - Mattress Reverse Stains

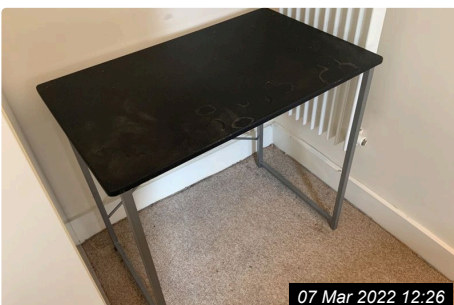
13.12	Left by tenant		Item added after Check In		
-------	----------------	--	---------------------------	--	--

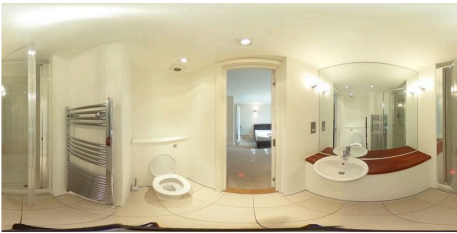
<p>07 Mar 2022 12:39</p> <p>Ref # 14.1</p>

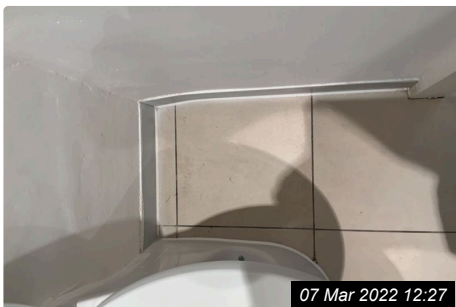
Ref # 14.10 - Marks and smudge is through out

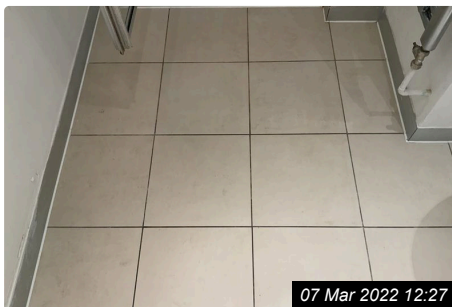
Ref # 14.10 - Marks and smudge is through out

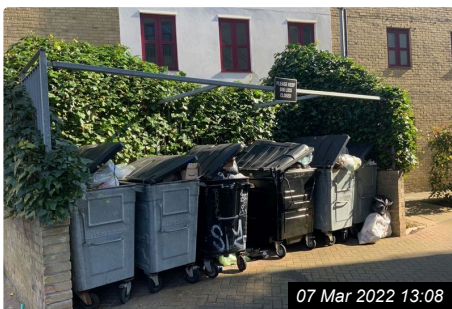
Ref	Name	Description	Condition at Inventory	Condition at Check Out	Additional Comments
16.1	Bin area	Bin Area	Item added after Check In
