Inventory & Check In

Inventory Company.

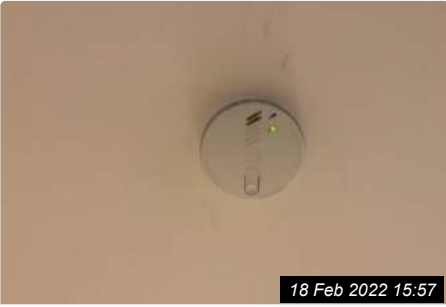
4. HEALTH & SAFETY | SMOKE & CARBON MONOXIDE ALARMS (CONT.)

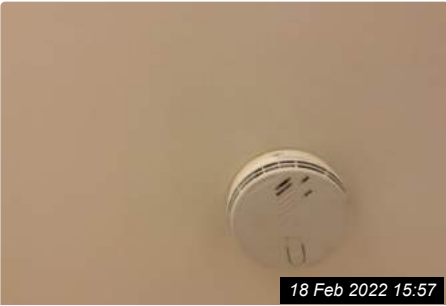
4.3	Smoke Alarm(s)	Entrance hallway	Alarm tested for power. Audible alarm noted	
-----	----------------	------------------	---	--

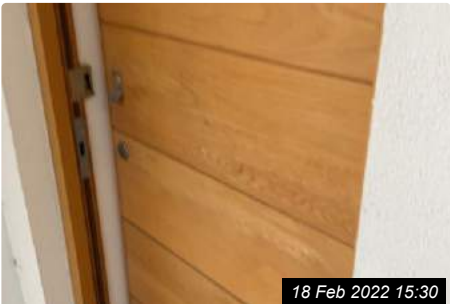
5. ENTRANCE / HALLWAY (CONT.)

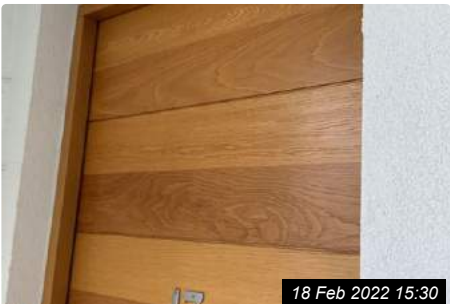
5.3	Door Frame	Brown wooden frame Silver hinges and fittings	Appears in good, clean condition. All in good, working order	
-----	------------	--	---	--

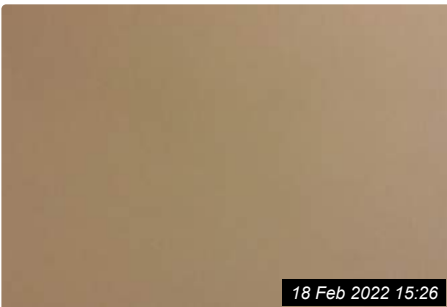
5.4	Ceiling	White Painted Plain	Appears in good, clean condition.	
-----	---------	---------------------	-----------------------------------	--

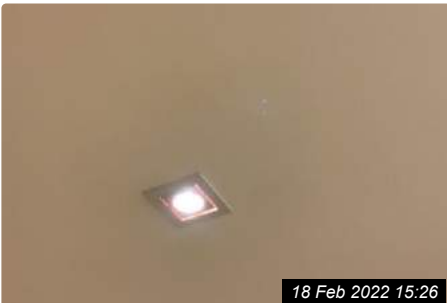
5.5	Lighting	Built-in spotlight Strip light	All in good, working order Appears in good, clean condition. Brown strip light cobwebs	
-----	----------	-----------------------------------	--	--

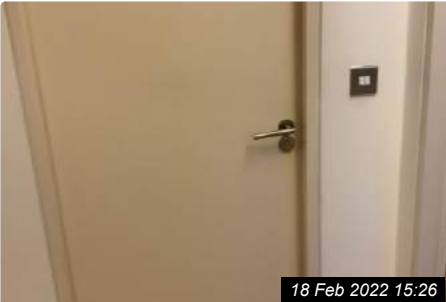
5.6.2	- Front Wall	Magnolia painted Nova bot doorbell receiver Chrome double switch	Appears in good, clean condition. Sockets and switches Not tested Appears in good condition	
-------	--------------	--	--	--

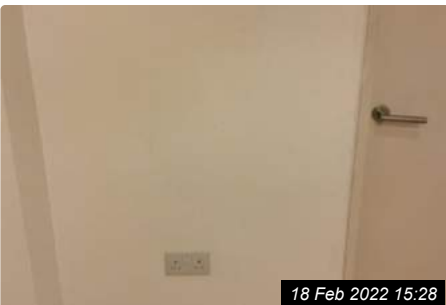
5.6.3	- Left Side Wall	Magnolia painted Noticeboard White plastic double socket White plastic open reach socket	Appears in good, clean condition. Sockets and switches Not tested Appears in good condition	
-------	------------------	---	--	--

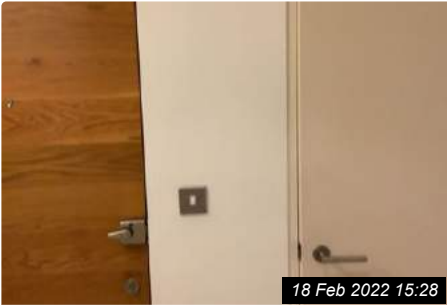
5.6.4	- Back Wall	Magnolia painted Chrome single switch Round White doorbell receiver	Appears in good, clean condition. Sockets and switches Not tested Appears in good condition
-------	-------------	---	--

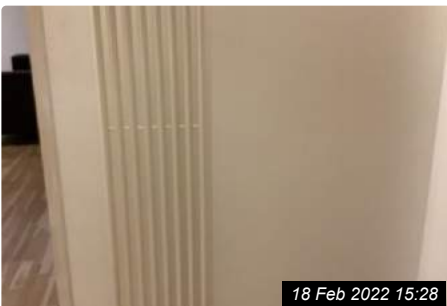
5.7	Heating	White Metal wall fitted vertical radiator	Not Tested Both knobs intact Appears in good, clean condition. Securily fitted
-----	---------	---	---

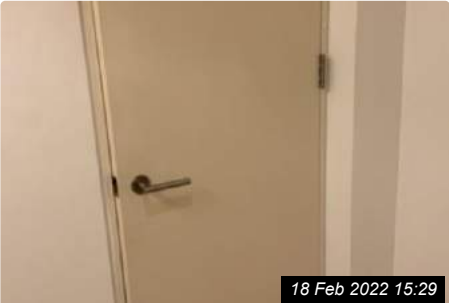
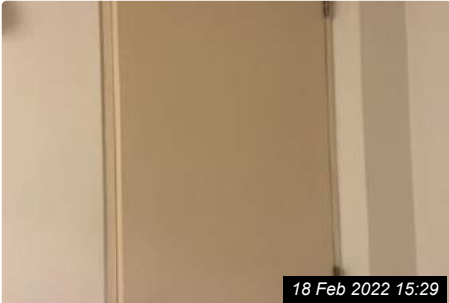
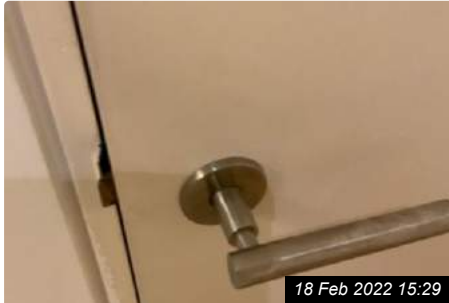
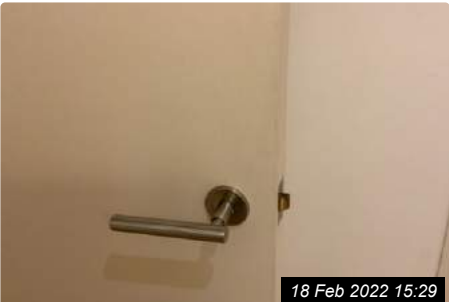
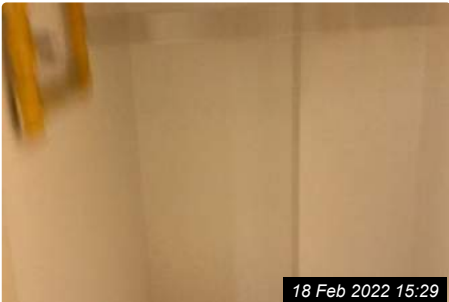
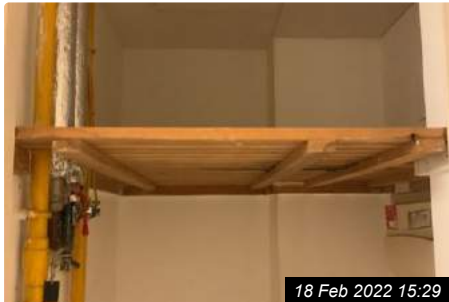
5.9	Storage Cupboard	White wooden door Silver handles Brownshill Where is fittings and fixtures	Appears in good, clean condition.

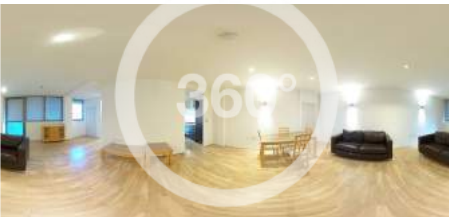
Ref	Name	Description	Condition	Additional Comments
6.1	360 Room overview

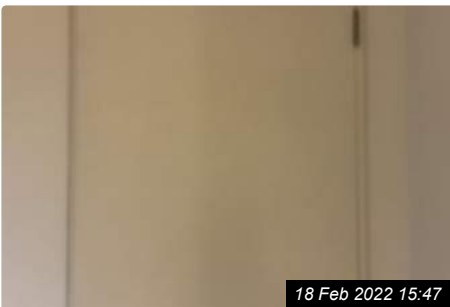
Appears in good, clean condition.
All in good, working order
Hinges and fittings intact

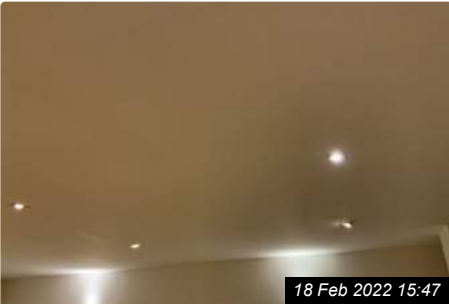
6.5	Lighting	Built in spot lights 4x Wall fitted spotliggths	Appears in good, clean condition. All in good, working order	
-----	----------	--	---	--

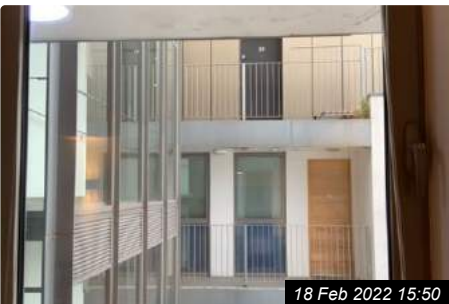
6.6	Window(s) / Sill first right	Grey Alumunium Double Glazed Grey Alumunium Handles White painted wooden sill	Glass intact and no damage All in good, working order Appears in good, clean condition. Sill Appears in good, clean condition.	
-----	---------------------------------	---	--	--

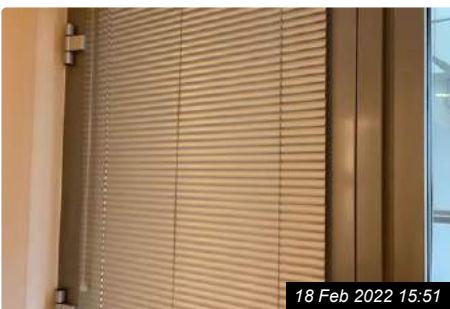
6.11	Blinds	Silver Aluminium Venetian Clear plastic handle Adjustment cords	Wall mounted safety bracket(s) / warning sign(s) not present; All in good, working order Appears in good, clean condition.	
------	--------	---	---	--

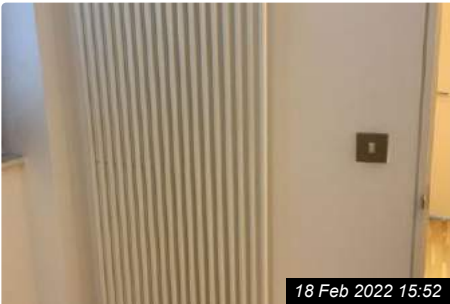
6.12	Heating	White Metal wall fitted vertical radiator	Not Tested Both knobs intact Appears in good, clean condition. Securely fitted	
------	---------	---	---	--

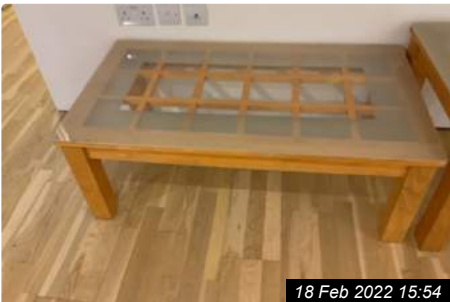
6.15	Coffee Table	Brown wooden frame and glass table top Matching side table	Appears in good, clean condition. Glass intact and no damage	
------	--------------	---	---	--

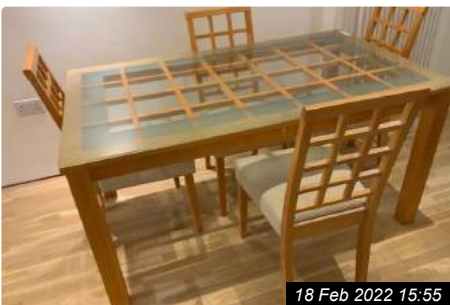
6.16	Dining table set	Brown wooden frame and glass table top	Glass intact and no damage Appears in good, clean condition. Chair seats have marks	
------	------------------	--	---	--

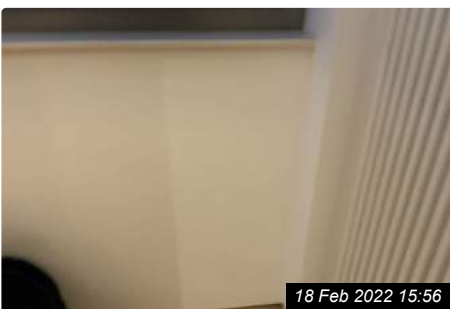
6.17	Walls	Walls below are described from their position as you enter the room.		
6.17.1	- Right Side Wall	Magnolia painted	Appears in good, clean condition.

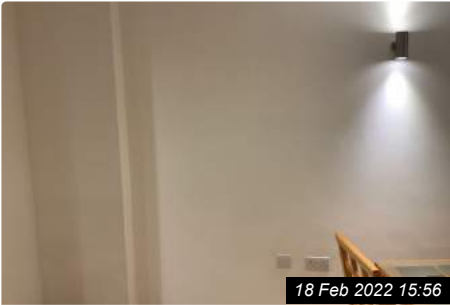
6.17.3	- Left Side Wall	Magnolia painted White plastic double socket White plastic phone socket	Appears in good, clean condition. Switches and sockets Not tested Appears in good, clean condition.	
--------	------------------	---	--	--

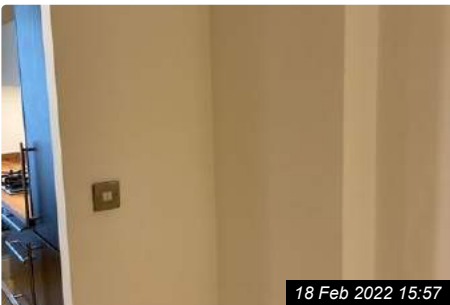
6.17.4	- Back Wall	Magnolia painted Chrome single switch Chrome double switches White plastic double socket White plastic Phone socket White plastic antenna socket	Appears in good, clean condition. Switches and sockets Not tested Appears in good, clean condition.	
--------	-------------	---	--	--

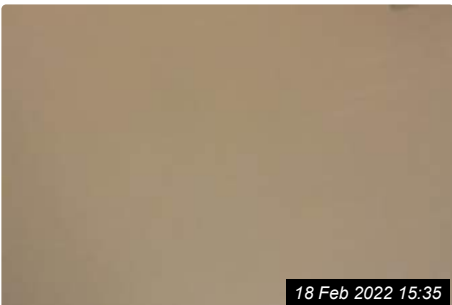
7.2	Ceiling	White Painted Plain	Appears in good, clean condition.	
-----	---------	---------------------	-----------------------------------	--

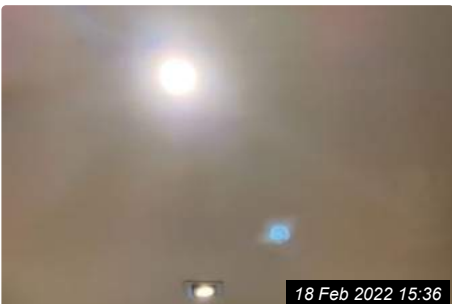
7.3	Lighting	3x Builtin spotlights 4x spotlights under the units	Appears in good, clean condition. All in good, working order	
-----	----------	--	---	--

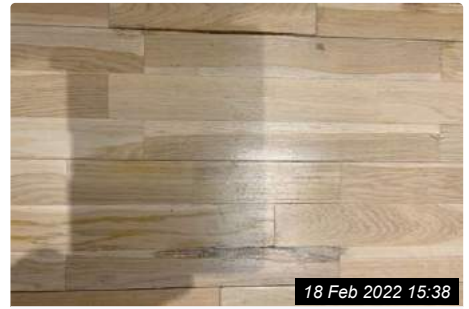
Ref # 7.4 - Back middle appears loose and space around

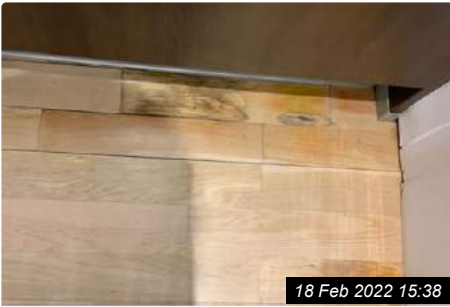
Ref # 7.4 - Left back panes loose and damaged

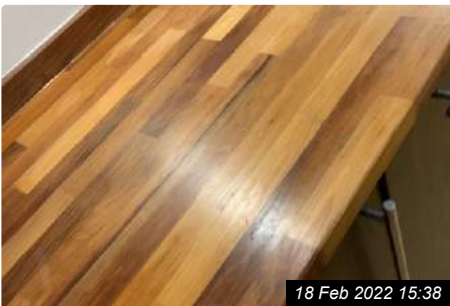
7.5	Kitchen Units			
7.5.1	- Worktop	Brown wooden	Condition consistent with use Worn in areas' right of sink

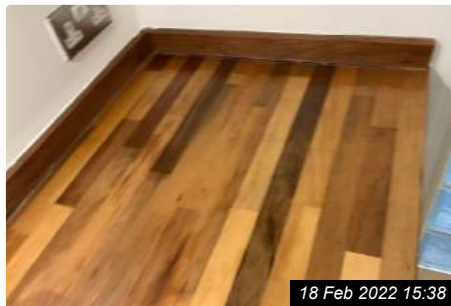
Ref # 7.5.1 - Worn in areas' right of sink

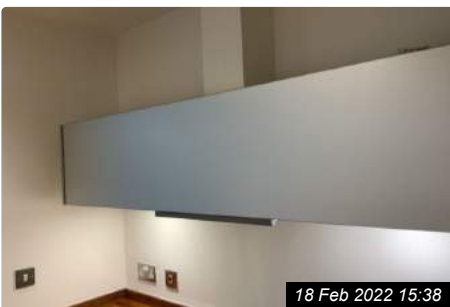
7.5.2	- Wall Units	Grey doors	Appears in good, clean condition.	
-------	--------------	------------	-----------------------------------	--

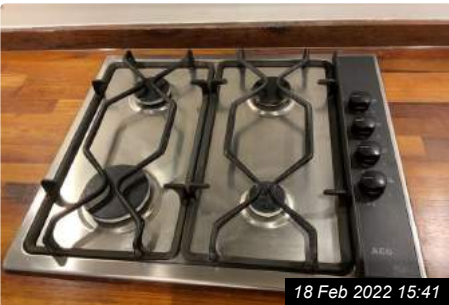
7.7	Hob	Hob integrated Serial Number - None found	Not tested Appears in good, clean condition. Knobs intact	
-----	-----	--	---	--

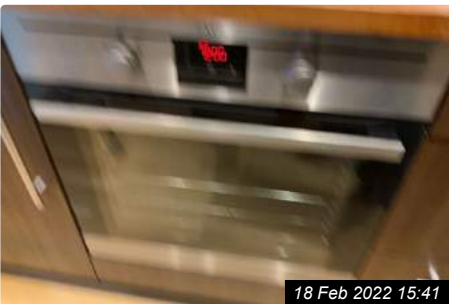
7.8	Oven	Serial Number - None found	Not tested Glass intact and no damage Appears in good, clean condition.	
-----	------	----------------------------	---	--

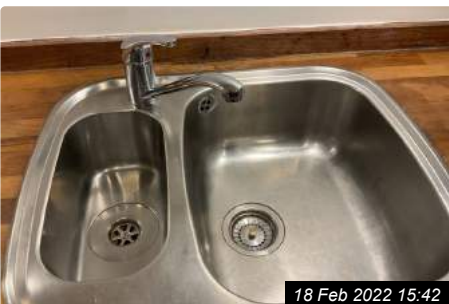
7.9	Sink	Stainless steel 1.5 bowl Chrome mixer tap	Appears in good, clean condition. No Limescale marks; RHS food catcher intact	
-----	------	--	---	--

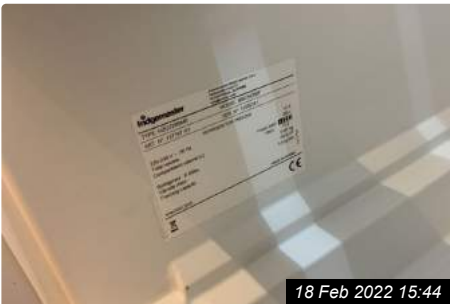
7.10	Fridge / Freezer	Fridge master integrated Serial number; 12030141	Not tested; Light bulb working Appears in good, clean condition.	
------	------------------	---	--	--

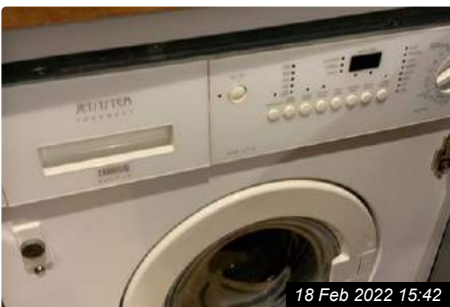
7.11	Washing Machine	Zanussi built in Serial Number - 32100058	Not tested Appears in good, clean condition. Rubber, Soap dispenser and drum in good clean condition	
------	-----------------	--	--	--

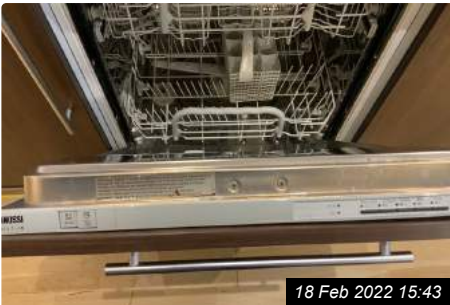
7.12	Dishwasher	Zanussi integrated Serial Number -32660119	Not tested Appears in good, clean condition.
------	------------	---	---

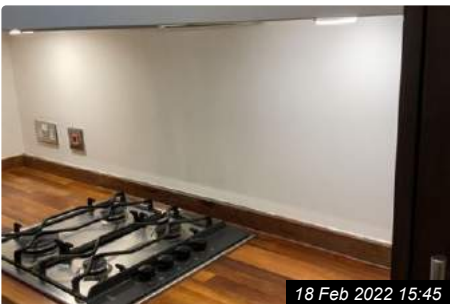
7.13	Walls	Walls below are described from their position as you enter the room.	
7.13.1	- Right Side Wall	White painted 2X Chrome double socket Chrome single switch with red button	Appears in good, clean condition. Switches and sockets Not tested Appears in good condition

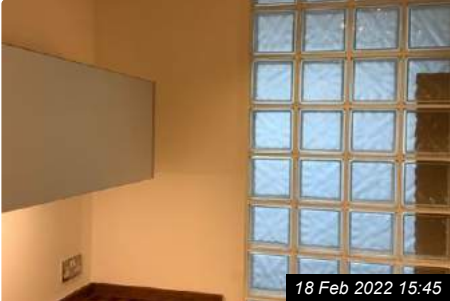
7.13.2	- Front Wall	White painted Glass block wall Chrome single switch	Appears in good, clean condition. Glass intact and no damage Switches and sockets Not tested Appears in good condition	
--------	--------------	---	--	--

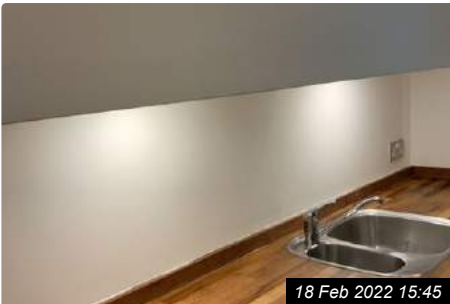
7.13.3	- Left Side Wall	White painted 2x Chrome double socket	Appears in good, clean condition. Switches and sockets Not tested Appears in good condition	
--------	------------------	--	--	--

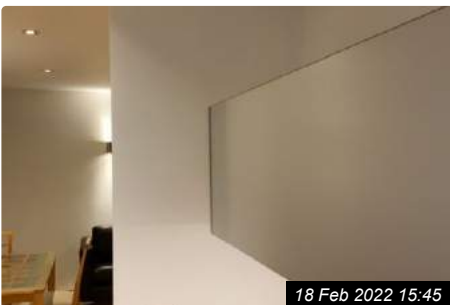
7.13.4	- Back Wall	White painted Chrome double switch	Appears in good, clean condition. Switches and sockets Not tested Appears in good condition	
--------	-------------	---------------------------------------	--	--

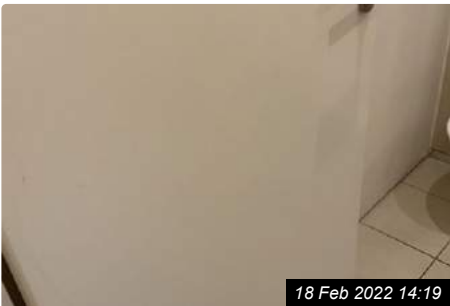
8.2	Door / Accessories	White wooden door Silver handles reverse and front	Minor brown mark near the handle Reverse Marks top of the door Otherwise In Good clean condition	
-----	--------------------	---	--	--

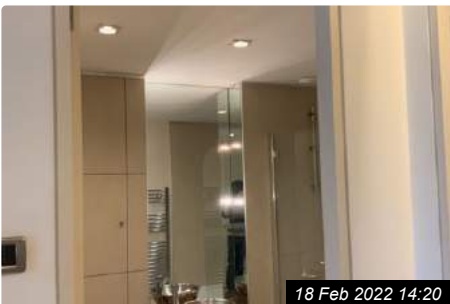
8.3	Door Frame	White painted wooden Silver hinges and fittings Silver threshold	Appears in good, clean condition. All in good, working order Threshold Condition consistent with use	
-----	------------	--	---	--

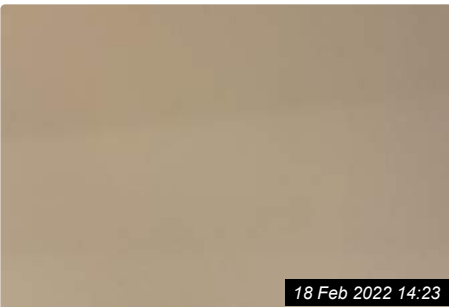
8.4	Ceiling	White painted plain	Appears in good, clean condition.
-----	---------	---------------------	-----------------------------------

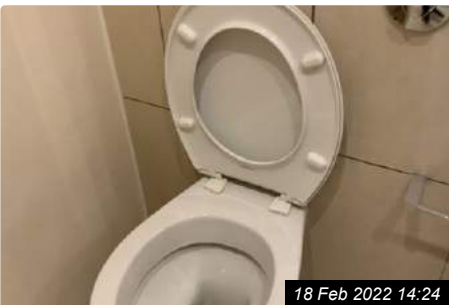
8.6	Toilet	White Ceramic/Porcelain toilet Pot White Plastic Seat top fixing standard toilet seat Chrome flush button	Appears in good, clean condition.; No Limescale marks
-----	--------	--	--

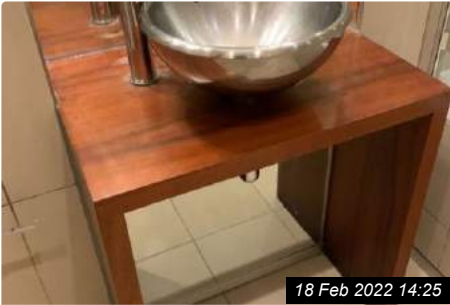
8.7	Basin	Silver round top fitted Chrome mixer tap Brown Wooden frame	Appears in good, clean condition.; No Limescale marks Wooden frame Condition consistent with use Worn back of sink	
-----	-------	---	--	--

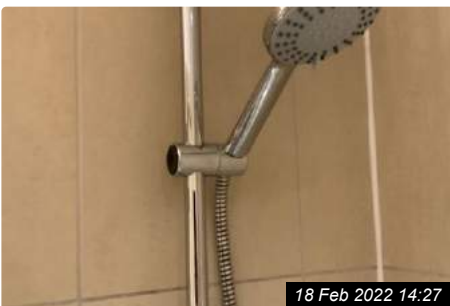
8.8.1	- Shower Head/ Fittings	White metal bathtub Chrome overflow Chrome waste fitting	Appears in good, clean condition. Drain cap loose and on the side	
-------	----------------------------	--	--	--

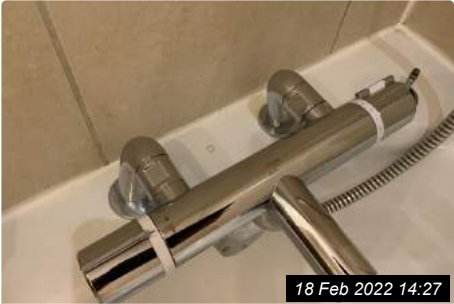
<p>Ref # 8.8.2</p>				
8.8.3	- Shower Screen	Chrome fittings Glass door panel	Appears in good, clean condition. Securely fitted No Limescale marks;

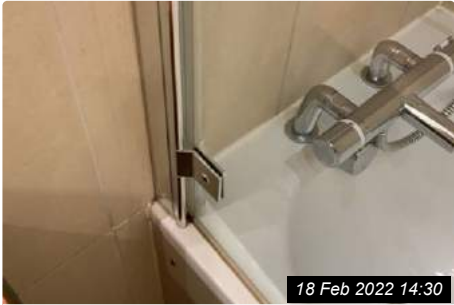
<p>Ref # 8.8.3</p>				
8.8.4	- Side panel	Light brown tiled Grey grouting	Appears in good, clean condition. Grouting clean and intact

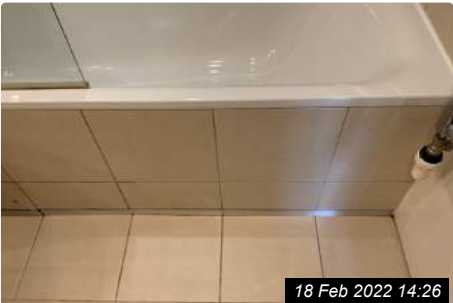
<p>Ref # 8.8.4</p>				
8.9	Heating	Chrome wall fitted single Panel	Not tested Appears in good, clean condition.; No Limescale marks Both knobs intact

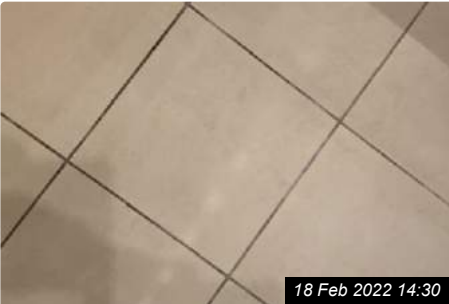
8.10	Flooring	Light brown tiled Grey grouting	Appears in good, clean condition. Grouting clean and intact	
------	----------	------------------------------------	--	--

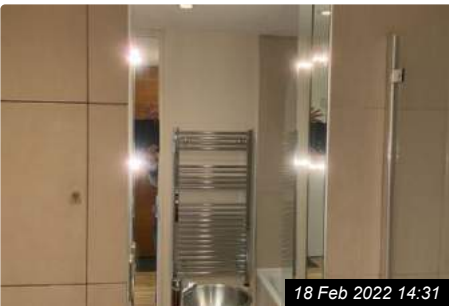
8.11	Wall Cabinet (Alcove)	Mirror panels sides and front	Appears in good, clean condition. Glass intact and no damage	
------	--------------------------	-------------------------------	---	--

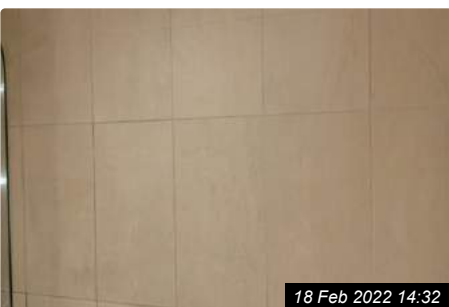
8.12	Walls	Walls below are described from their position as you enter the room.		
8.12.1	- Right Side Wall	Light brown tiled Grey grouting Chrome strip top level	Appears in good, clean condition. Grouting clean and intact Sealant intact

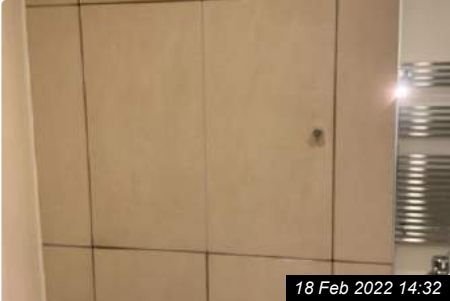
8.12.2	- Front Wall	Light brown tiled Grey grouting Storage Tiled door Silver round knob Silver strip	Appears in good, clean condition. Grouting clean and intact Sealant intact	
--------	--------------	--	--	--

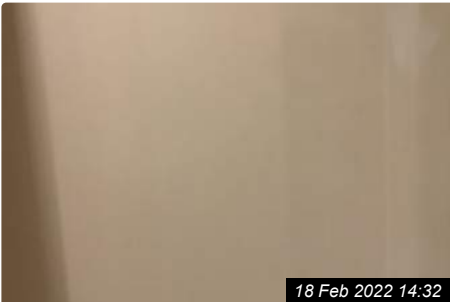
8.12.3	- Left Side Wall	Magnolia painted	Appears in good condition	
--------	------------------	------------------	---------------------------	--

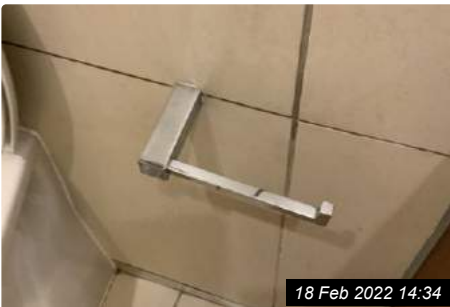
Appears in good, clean condition.
Slightly loose

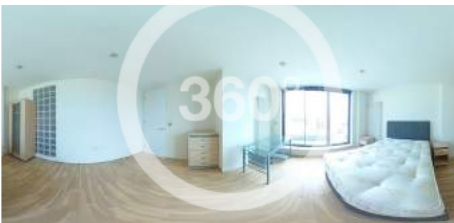
Ref	Name	Description	Condition	Additional Comments
10.1	360 Room Overview

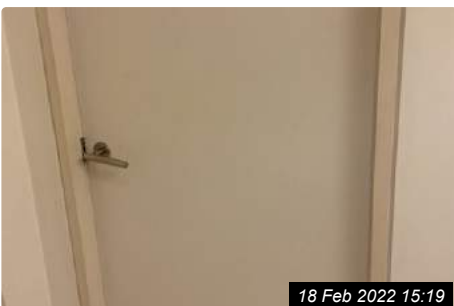
10.2	Door / Accessories	White wooden door Silver handles reverse and front	Reverse Scuff mark left lower level Otherwise in good, clean condition.	
------	--------------------	---	---	--

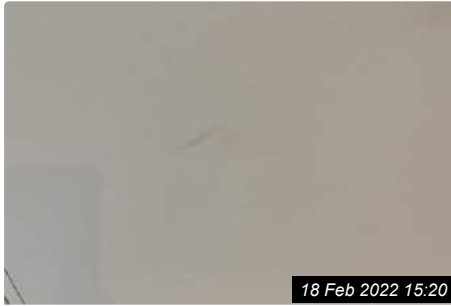
Ref # 10.2 - Scuff mark left lower level

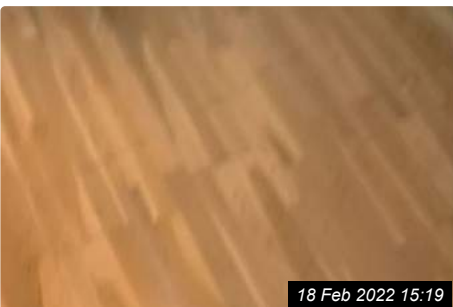
10.3	Door Frame	White painted wooden Silver hinges and fittings Brown threshold	Appears in good, clean condition. All in good, working order Threshold Condition consistent with use	
------	------------	---	---	--

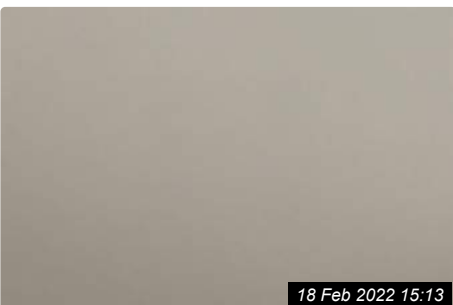
10.4	Ceiling	White Painted Plain	Appears in good, clean condition.	
------	---------	---------------------	-----------------------------------	--

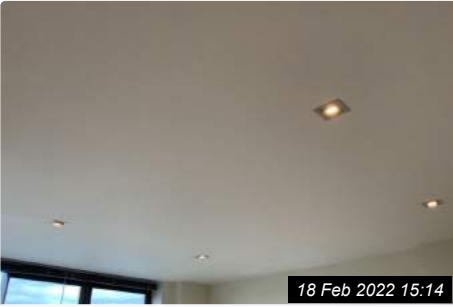
10. BEDROOM 1 (CONT.)

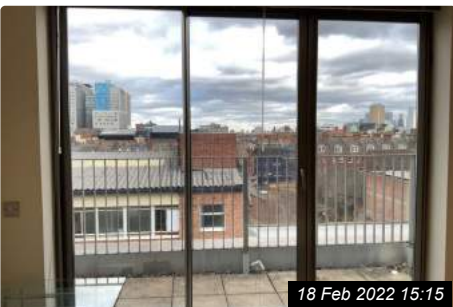
10.6	Window(s) / Sill / Sliding door	Grey Aluminium Double Glazed Grey Aluminium Handles White painted wooden sill	Glass intact and no damage All in good, working order Appears in good, clean condition. Sill Appears in good, clean condition.
------	---------------------------------	---	--

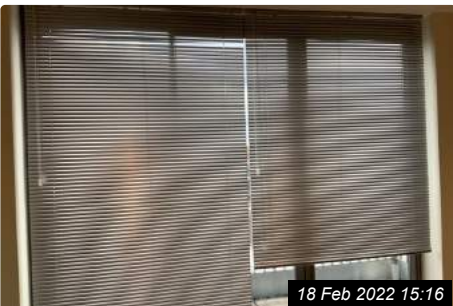
10.7	Blinds	2x Silver Aluminium Venetian Clear plastic handle Adjustment cords	Wall mounted safety bracket(s) / warning sign(s) not present; All in good, working order Appears in good, clean condition.
------	--------	---	--

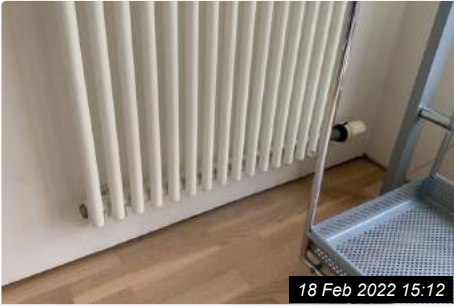
10. BEDROOM 1 (CONT.)

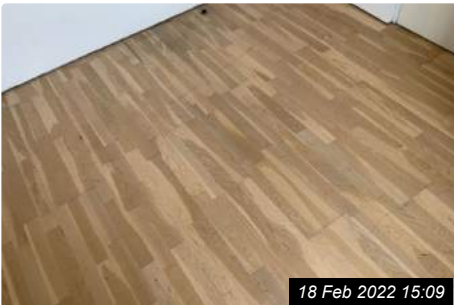
Condition consistent with use
Large grey line near the door
Scuffs and marks throughout

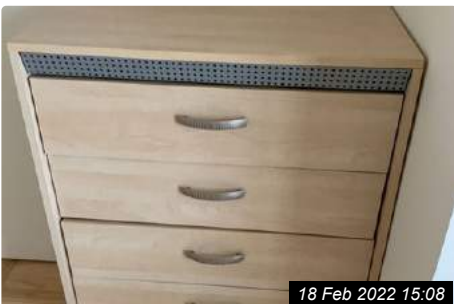
Appears in good, clean condition.

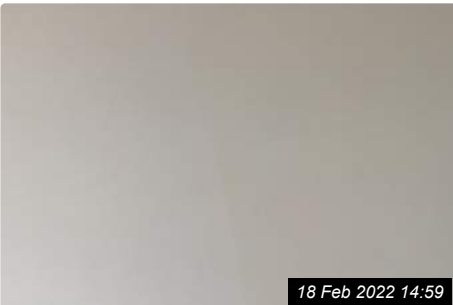
10.11	Walls	Walls below are described from their position as you enter the room.		
10.11.1	- Right Side Wall	Magnolia painted Glass block wall White plastic double socket White plastic phone socket	Appears in good, clean condition. Glass intact and no damage Sockets and switches Not tested Appears in good, clean condition.

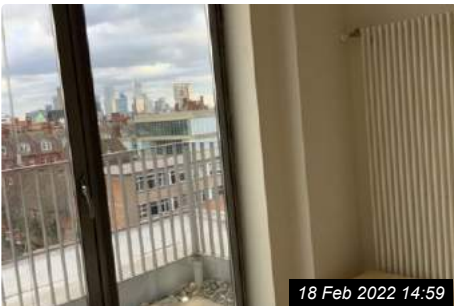
Sockets and switches
Not tested
Appears in good, clean condition.

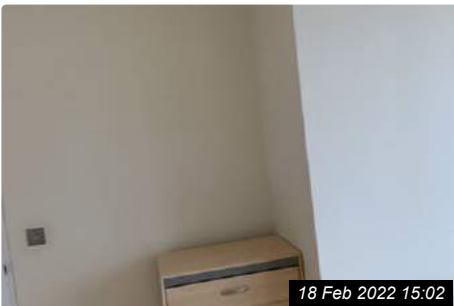
Magnolia painted
White plastic double socket
White plastic phone socket
White plastic antenna socket
Chrome single push buttonAppears in good, clean condition.
Minor marks around the chrome switchSockets and switches
Not tested
Appears in good, clean condition.

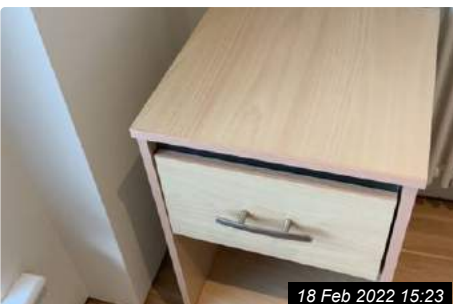
10.13	Bedside table	Brown wooden single drawer Silver handle	RHS drawer marks internally Otherwise appears in good, clean condition. Handle intact	
-------	---------------	---	--	--

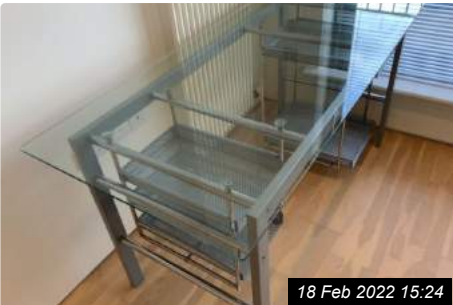
Grey metal desk
Glass topAppears in good, clean condition.
Glass intact and no damage

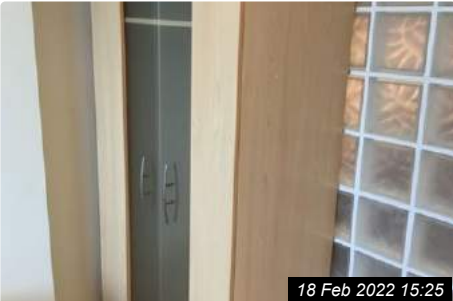
Brown wooden with glass panel doors
Silver handlesAppears in good, clean condition.
Handles intact
Glass intact and no damage

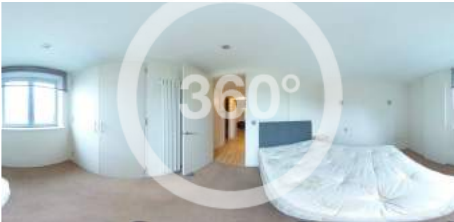
Ref	Name	Description	Condition	Additional Comments
11.1	360 Room Overview

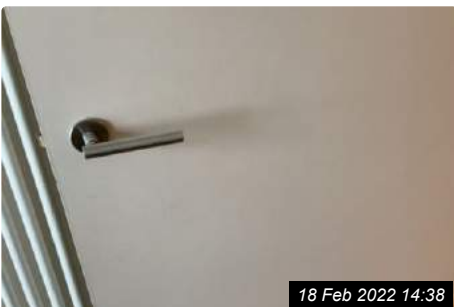
11.2	Door / Accessories	White wooden door Silver handles reverse and front Blue plastic doorstopper	Front Scuff and coloured Marks lower level Reverse 2marks upper level White mark mid level Otherwise Appears in good, clean condition.	
------	--------------------	---	--	--

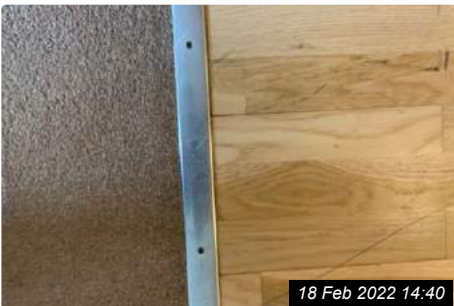
Threshold
Condition consistent with use

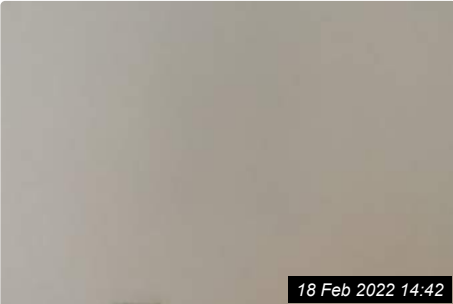
11. BEDROOM 2 (CONT.)

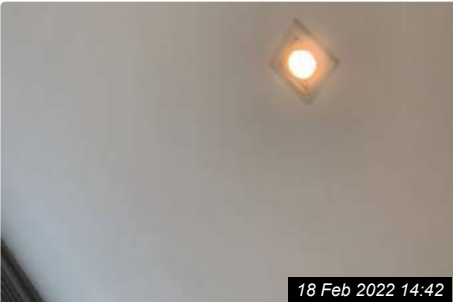
11.5	Lighting	2x built in Spotlights 2x wall fitted spotlights	Appears in good, clean condition. All in good, working order	
------	----------	---	---	--

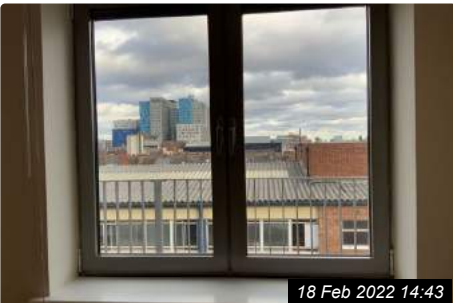
11.6	Window(s) / Sill	Grey Aluminium Double Glazed Grey Aluminium Handles White painted wooden sill	Glass intact and no damage All in good, working order Appears in good, clean condition. Sill Appears in good, clean condition.	
------	------------------	---	--	--

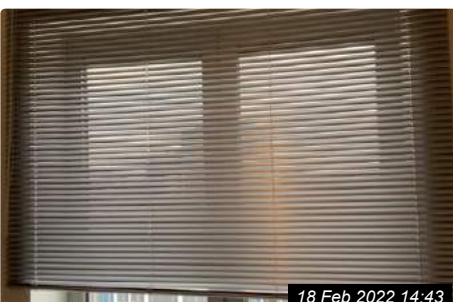
11.7	Blinds	Silver Aluminium Venetian Clear plastic handle Adjustment cords	Wall mounted safety bracket(s) / warning sign(s) not present; All in good, working order Appears in good, clean condition.	
------	--------	---	---	--

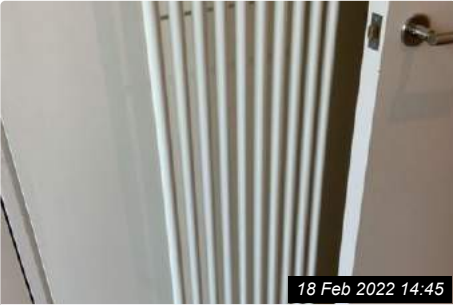
11.8	Heating	White Metal wall fitted vertical radiator	Not Tested Both knobs intact Appears in good, clean condition. Securely fitted	
------	---------	---	---	--

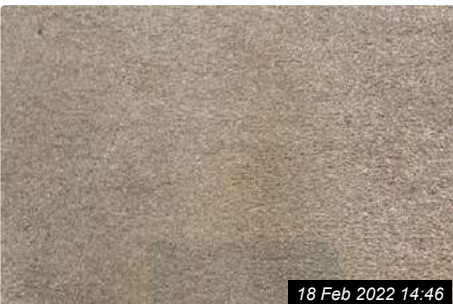
11.9	Flooring	Brown fitted carpet	Condition consistent with use Good and clean	
------	----------	---------------------	---	--

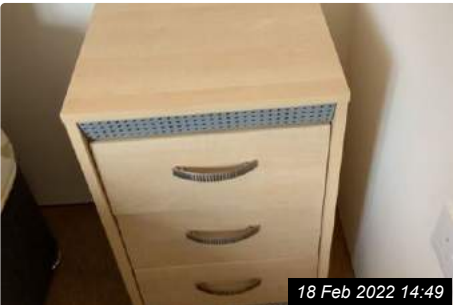
11.11	Bedside Cabinet(s)	Brown wooden Silver handles 3 drawers	Drawers have marks inside Externally in good, clean condition.	
-------	--------------------	---	--	--

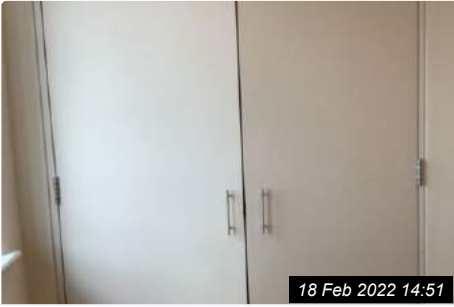
11. BEDROOM 2 (CONT.)

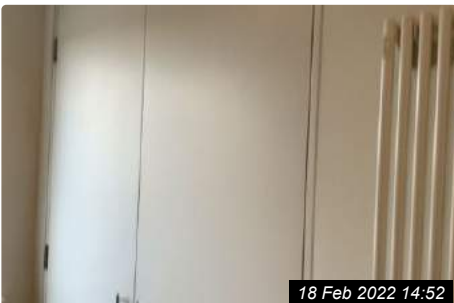
11.13	Walls	Walls below are described from their position as you enter the room.		
11.13.1	- Right Side Wall	Magnolia painted	Behind the door marks lower level Otherwise in good clean condition

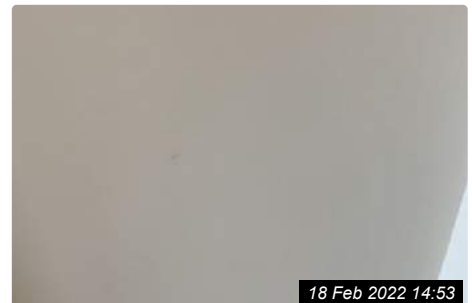
Ref # 11.13.1 - Behind the door marks lower level

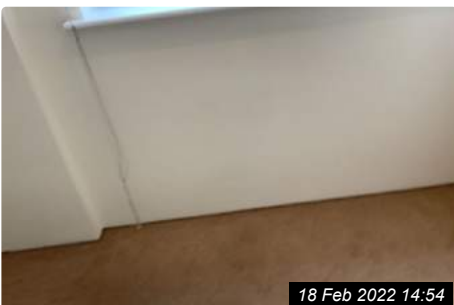
11.13.2	- Front Wall	Magnolia painted	Appears in good, clean condition.	
---------	--------------	------------------	-----------------------------------	--

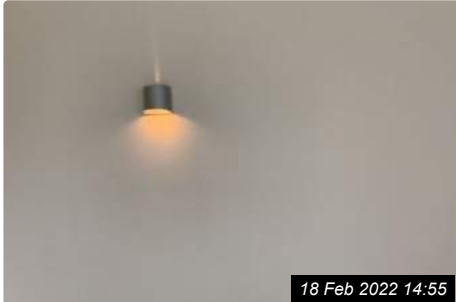
11.13.3	- Left Side Wall	Magnolia painted 2x white plastic double socket Chrome single switch White plastic phone socket	Appears in good, clean condition. Around sockets overpaint mark Overpainted marks LHS Sockets and switches Not tested Appears in good, clean condition. Chrome switch Paint marks on the sides	
---------	------------------	--	---	--
